## Managing Debris Flow Risks

Source: Mountain Research and Development, 24(1):19-23.

## Security Measures for a Hazard-Prone Resort in Switzerland

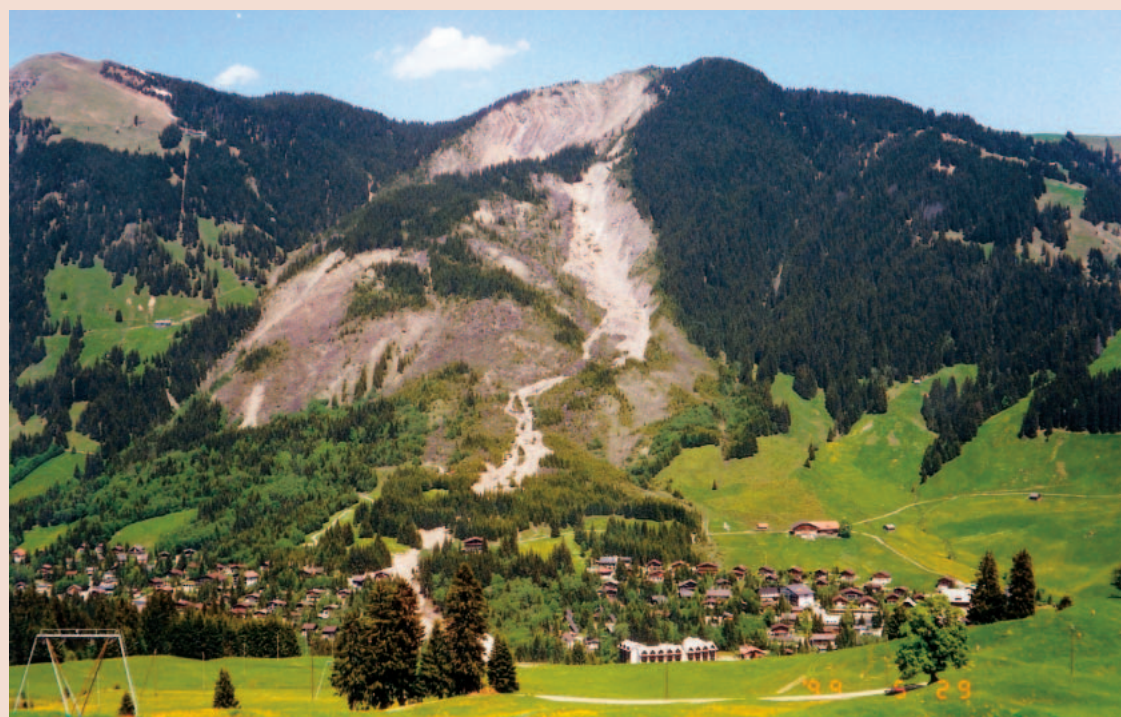
**FIGURE 1** The tourist resort of Sörenberg, located in the Entlebuch Biosphere Reserve, Central Switzerland. The village is located at the foot of a deep-seated landslide complex. The bright surfaces mark the geomorphological zones active in 1999. (Photo by author)

Sörenberg is a typical small tourist resort located on the periphery of the Swiss Alps in Central Switzerland (Figure 1). The village has developed only during the last 40 years; prior to that, it was known as a spa. Today, about 800 housing units—mainly secondary homes (chalets and tourist apartments)—are situated on old debris flow deposits. In addition, a number of sports and leisure facilities have been constructed in recent years. The slopes above the village belong to a large (15 million m<sup>3</sup>)

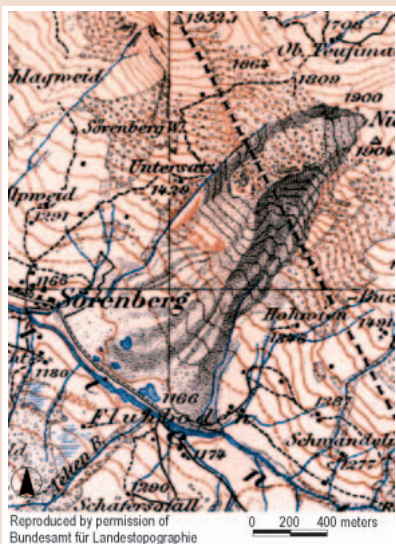
**FIGURE 2** 1918 topographic map, showing the open scars on either side of the mass and the typical accumulation features developed in 1910 and 1912. The few houses with the church (at the center of the village) are located in a safe place. (Map reproduced by permission of Bundesamt für Landestopographie, BA024084)

Analysis of past events makes an important contribution to the understanding of present and future hazards in a particular location. A number of historic documents such as maps (Figure 2), postcards or photographs, as well as a detailed description of the 1910 events by the famous geologist Albert Heim, provided the necessary information to reconstruct the sequence of landslide events in the 20<sup>th</sup> century. Between 1860 and 1910 the entire complex shifted downhill by more than 30 m in a large vertical movement. In 1910 another large vertical movement occurred, lasting several days and causing 2 major lateral collapses and massive debris flows of over 3 million m<sup>3</sup>. Throughout the rest of the 20<sup>th</sup> century development was irregular. Several lateral and frontal collapses occurred in 1912, 1922, and 1986, with 6 decades of geomorphic inactivity in between.

At the beginning of the 20<sup>th</sup> century the area now occupied by the village was used as grazing land. The map (Figure 2) indicates that the existing few houses in Sörenberg were arranged around the church in a safe place. Within the accumulation area of the 1910, 1912 and 1922 debris flows, only a very few isolated houses were destroyed.

Sörenberg's development into the tourist resort that it is today took place only over the past 30 to 40 years. The 1918 map (Figure 2) clearly shows that at that time only very few buildings were located in what was once a highly active accumulation area. Today this area is completely covered by houses (Figure 3). The long period of geomorphic inactivity following the events of 1922 was interpreted as a sign of future security. An analysis by experts in 1974 proved that there was no immediate threat, but did not altogether exclude the possibility of damaging events. An indication of the uncertainty of the situation was provided by displacement measurements begun in 1978. These clearly show that the whole mass is continuously moving about 3 to 10 cm per year. The speed of this movement increased dramatically in 1999 but has slowed down again since.

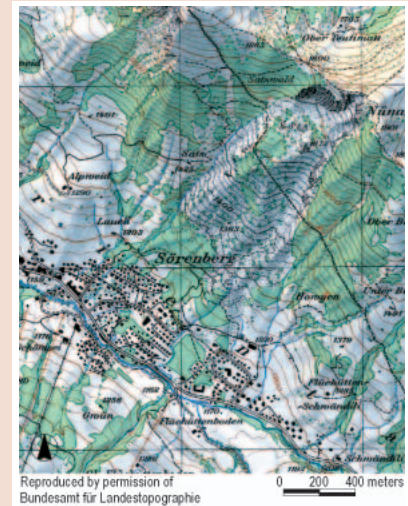
**FIGURE 3** 1993 topographic map, showing how the village has developed in the past 30 years in the area where debris flow formerly accumulated. (Map reproduced by permission of Bundesamt für Landestopographie, BA024084)

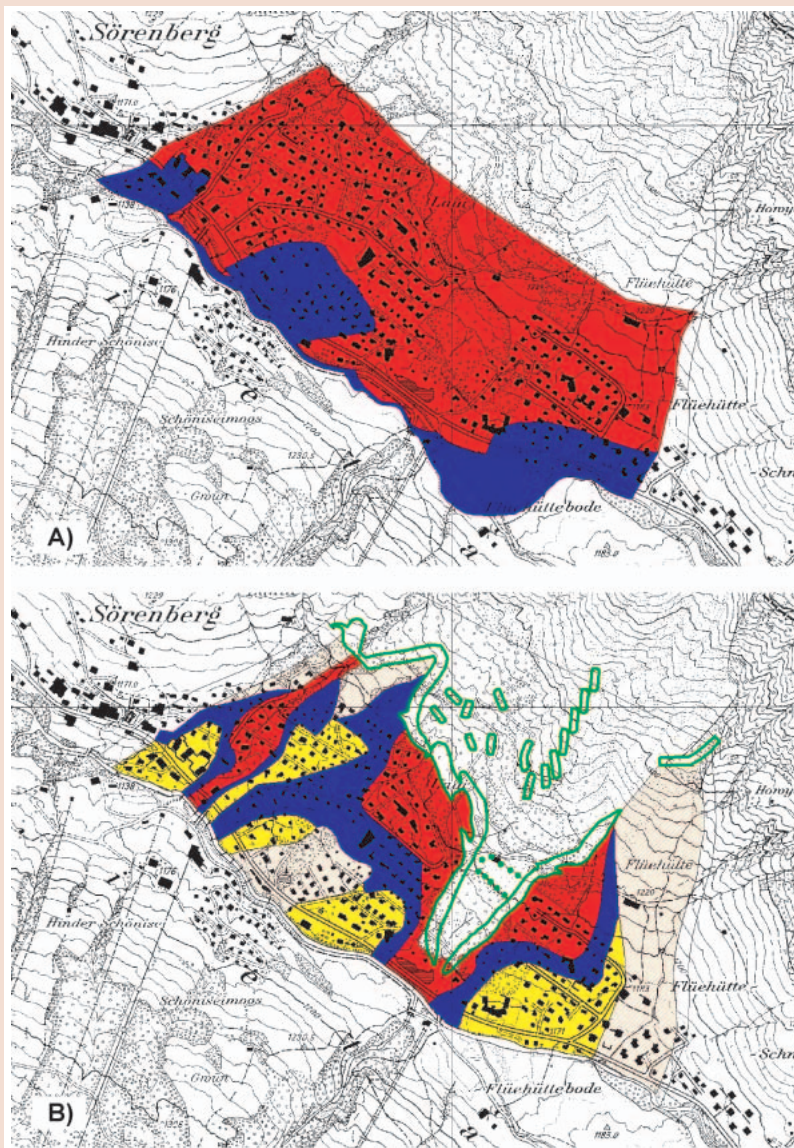
**FIGURE 4, A AND B** Hazard map for Sörenberg. Top (A) before, and bottom (B) after the implementation of the planned structural measures. Red: high degree of hazard; blue: moderate degree of hazard; yellow: low degree of hazard; yellow-white: hazards with a very low probability of occurrence; green: planned structural measures. (Maps reproduced by permission of swisstopo, BA035840)

Secondary processes caused by primary movement occur only after relatively long intervals. It can be concluded that Sörenberg remains at risk. The risk of further collapses and subsequent flows must be taken into account, even though conditions above the village are currently calm. However, it is assumed that large-scale events such as the ones in 1910 are no longer possible. These facts were considered in the hazard map that was prepared in 2001 (Figure 4A).

The first step towards definition of protective measures is a thorough investigation of all hazards and the creation of a hazard map. In Switzerland, such maps are based on definite probability and magnitude classes. Under present conditions, most of the village is within red and blue hazard zones (Figure 4A), ie those subject to a high or moderate risk, respectively. This constitutes a de facto ban on future economic development of the village: construction of new houses and major changes to existing houses are normally not permitted within the red zone. This, of course, was not acceptable to the municipal authorities. Solutions had to be found that would guarantee the safety of the population while at the same time allowing moderate development of the village.

- A set of regulations in the local land use plan and building code defines what is possible in red, blue and yellow zones. These regulations should curb further increase of vulnerability (see Table 1 and Figure 4B).
- In addition to village regulations, plans call for a complete ban on grazing throughout the landslide-prone area as well as an increase in forest cover.
- Municipal and cantonal authorities established a hazard map for the whole area in order to show whether adjacent areas are more suitable for village development. Unfortunately, there are only a few places that are appropriate as housing lots.

- People argued that the primary process should be stopped. Geophysical investigations showed, however, that control of the water table in this extremely fractured and fast-moving mass is hardly possible;
- A number of (reasonable) structural protection measures (Figure 4B, green markings) are planned to reduce the risks to a bearable level. But even with these protection measures, some parts of the village remain in the red danger zone. Owing to financial constraints, the state would like to minimize these measures. The local authorities, on the other hand, have an interest in reducing the red zone as much as possible. Costs of about CHF 14 million (US\$ 10 million) will be shared by the canton and the municipality, with heavy subsidies from the federal government. Home owners may also make contributions.
